**FIVE-YEAR REVIEW REPORT FOR
NL INDUSTRIES/TARACORP LEAD SMELTER SUPERFUND SITE
Granite City, IL**

**U.S. Environmental Protection Agency
Region 5
Chicago, IL**

3/28/2014

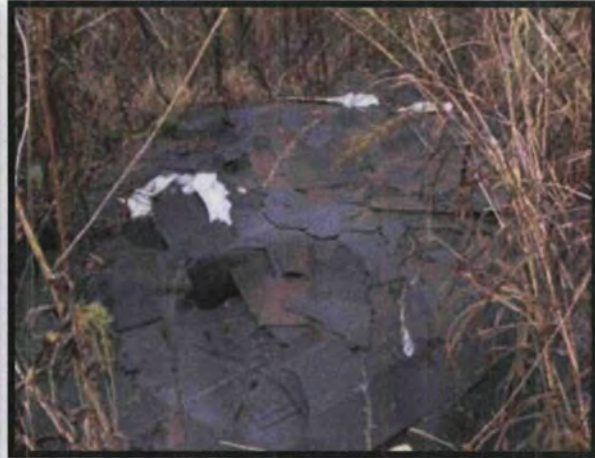
Photograph 8: Debris (roof shingles) at Slough Road.

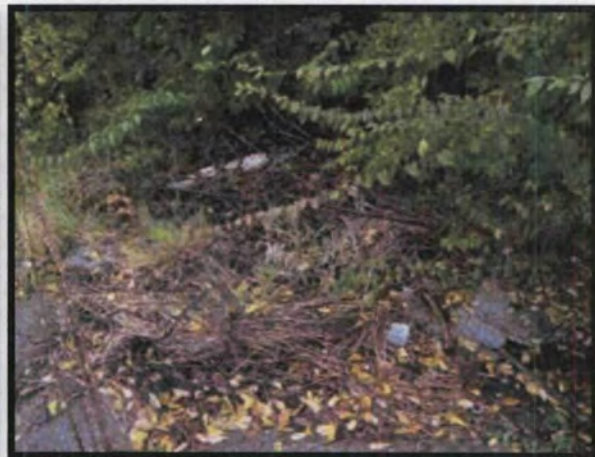
Photograph 10: Debris (plastic containers, etc.) at Slough Road.

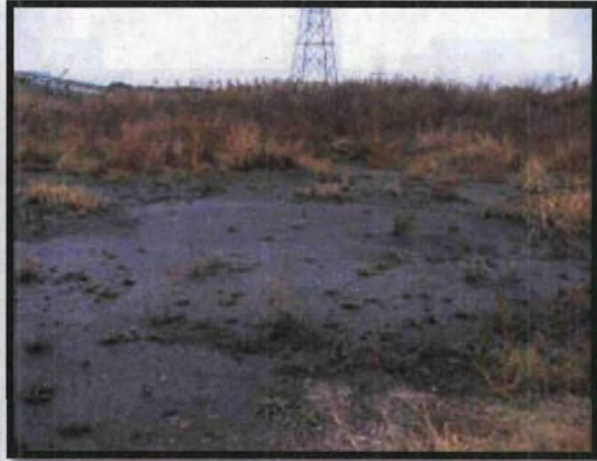
Photograph 14: Pond (west of Robin's Nest Lounge); no surface water in impoundment.

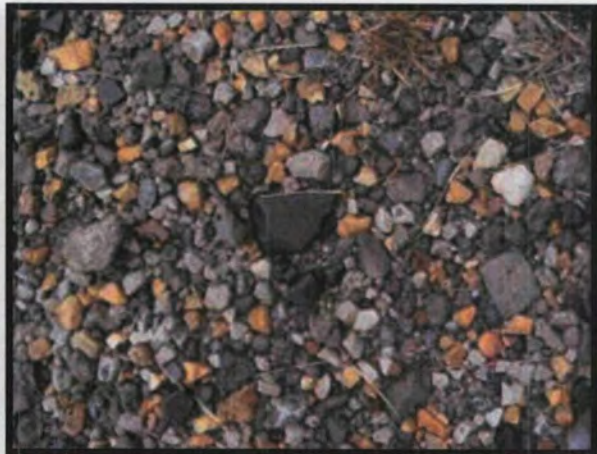
During the FYR inspection, Slough Road was found to be inaccessible because of the concrete barriers. However, battery chips were noted to be disbursed in the nearby parking area leading to the road and tavern. There was no evidence of exposure to the chips and the likelihood is small since some of the chips were dispersed away from the capped area and there was no evidence that the road is frequented by visitors. However, to assure that no unanticipated exposures to the chips are occurring, following this review, consideration will be given by U.S. EPA and the PRP Group to additional actions such as removal or capping, and/or placing additional restrictions, or placement of conspicuous notices.

Photograph 18: Battery chips in gravel area.

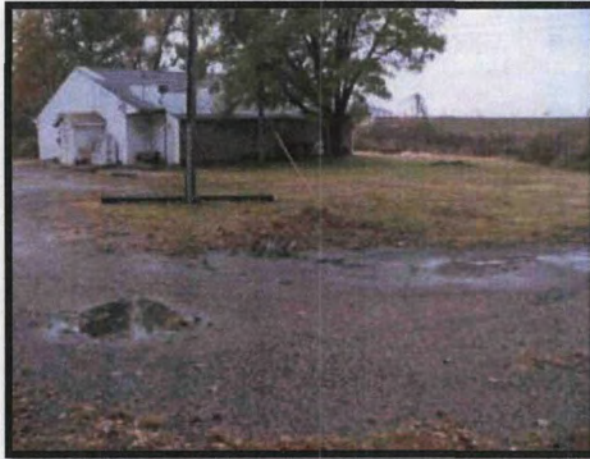
Photograph 19: Gravel area (scattered battery chips) adjacent to Slough Road.

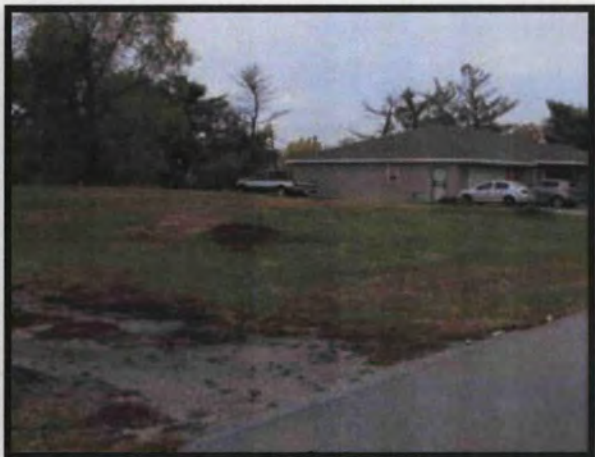
Photograph 6: Eagle Park Acres – former soil pile area 2 along Watson Street (soil piles from ACOE sanitary sewer installation project have been removed and property has been revegetated).

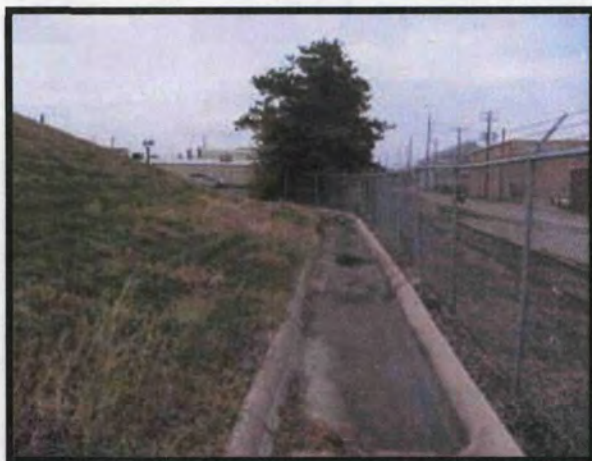
Photograph 7 and Photograph 8: Concrete drainage swale, fence, and vegetation, northeast side of Taracorp pile along 16th Street (view northwest).

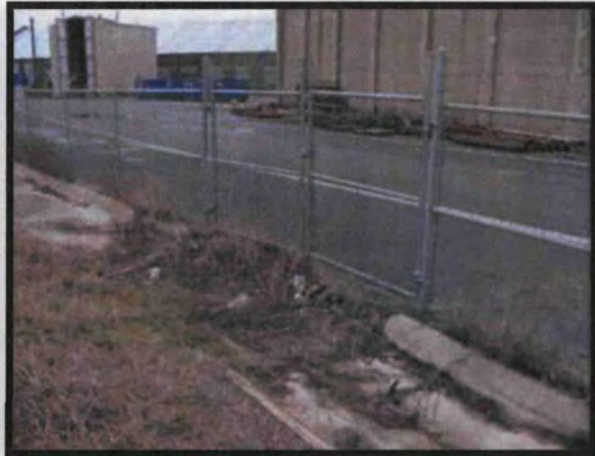
Photograph 14: Fence, gate along northwestern side of Taracorp pile (view southwest).

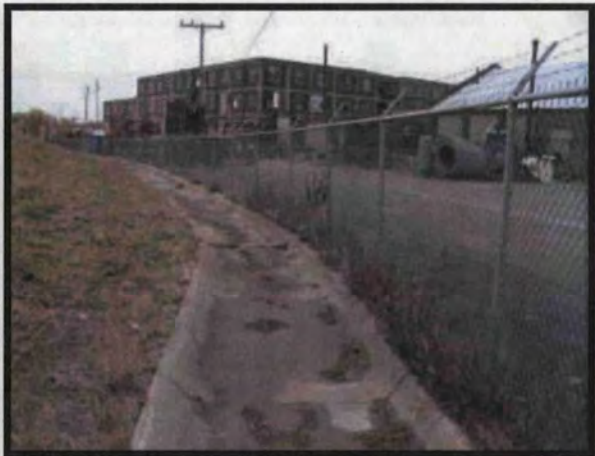
Photograph 18: Concrete drainage swale and vegetation near base of western side of Taracorp pile (view south).

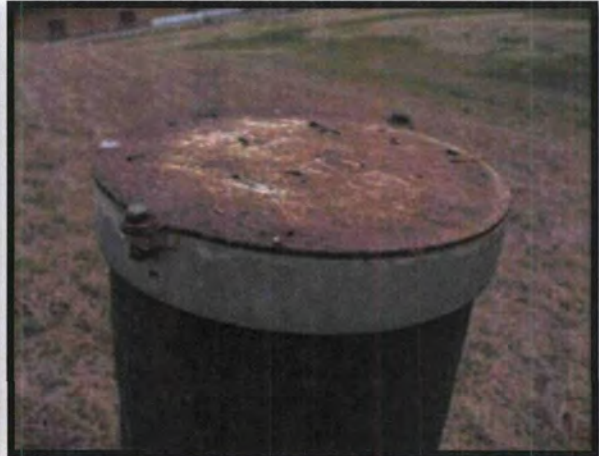
Photograph 43: Locked lid on leachate riser pipe (locked lid installed fall 2007).

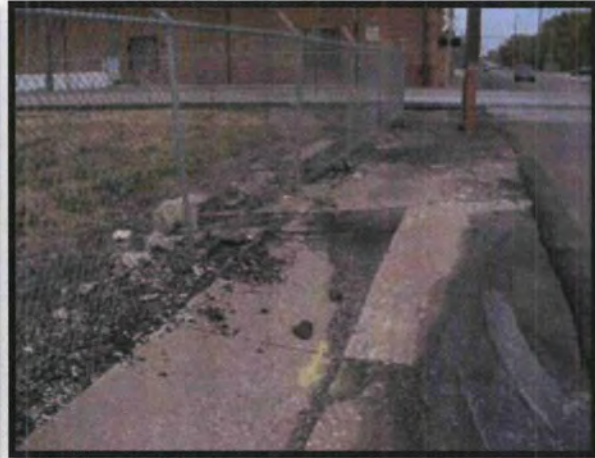
Photograph 67: Fence, sidewalk, and vegetation along State Street (previous hole filled with crushed stone by Munie personnel in 2007).
